Full Report

Project: ID 136

Building Details			
Building identifier:	///mercy.porridge.cornering		
Address:	Test Rig located at: Whitehall Commercial, HR1 4FL		
Type:	Dwelling	Description:	other
Status:	TestStatus.Review	Construction:	timber
Contractor:	-	Heating Source:	other
SAP reference:	-	SAP software:	-
Floor area (m ²):	5.2	Property height (m):	1.54
Envelope (m ²):	28.47	Volume (m ³):	8.0
Air Perm (m ³ /hm ² @50PA):	10.0 (designed)	25.8 (measured)	
Number of ring mains:	1	Passive Property?	-

Test Details			
Date:	10-01-2022		
Heating Phase:	22:00 UTC - 02:00 UTC	Cooling Phase:	02:00 UTC - 06:00 UTC
External Conditions:	Average 8.6°C (min 8.3°C, max 8.7°C), max 13.0kmph winds, 0.2mm precipitation		
Temporary Sealing:	Temporary seals in place		
Notes:	Test 1 - without Insulfix product applied to rafters.

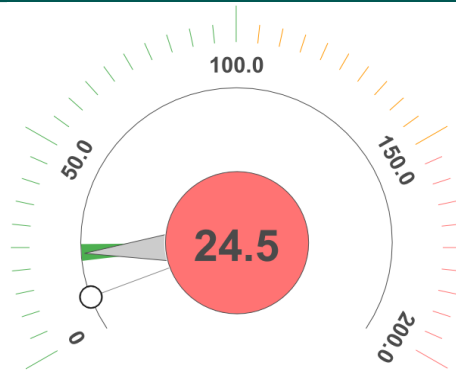
Result Summary (HTC)

Test Results			
This is to certify that the above named building has been tested by an approved Veritherm Testing Engineer.			
Measured Veritherm Result:	24.5 W/K		
Confidence Range:	22.0 W/K - 27.0 W/K		
	Designed	Measured	
Fabric	7.374 W/K	21.0 W/K	
Air Infiltration	1.4 W/K	3.5 W/K	
Heat Transfer Coefficient	8.77 W/K	24.5 W/K

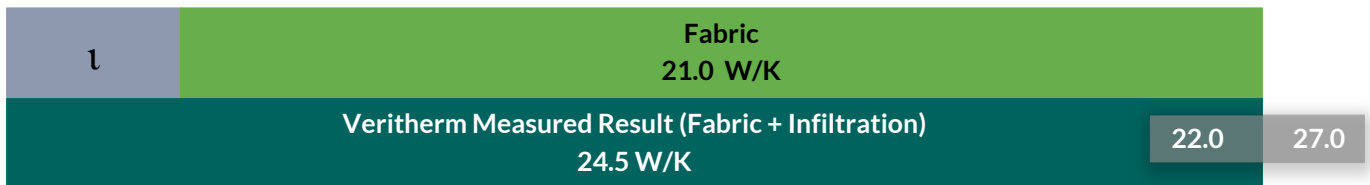
Measured

1 Infiltration: 3.5 W/K**

** Infiltration is calculated from provided air permeability data

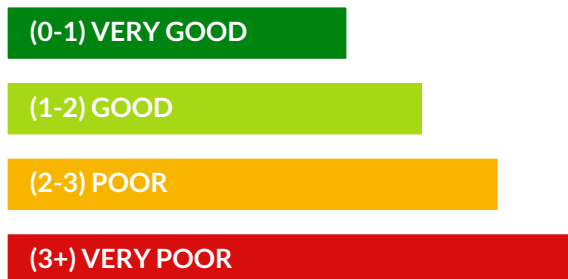
Thermal Efficiency Rating

Very energy efficient - lower running costs

Performance Gap
-179%

Not energy efficient - higher running costs

Average U-Value:	0.74 W/m ² K
------------------	-------------------------
