Full Report

Project: ID 138

Building identifier: mercy.porridge.cornering

Test Details			
Date:	12-01-2022		
Heating Phase:	10:30 UTC - 14:30 UTC	Cooling Phase:	14:30 UTC - 18:30 UTC
External Conditions:	Average 2.9°C (min 1.4°C, max 5.0°C), max 4.0kmph winds, 0.0mm precipitation		
Temporary Sealing:	Temporary seals in place		
Notes:	Test 2 - with Insulfix product applied to rafters

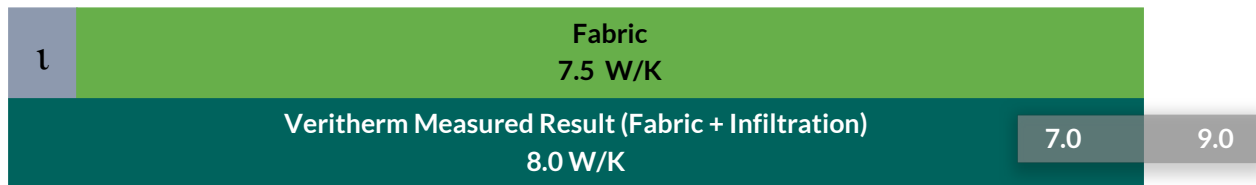
Measured

1 Infiltration: 0.5 W/K **

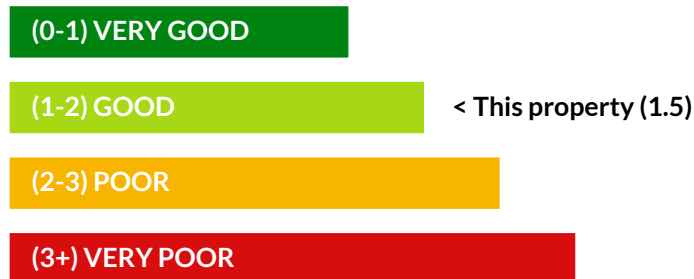
Thermal Efficiency Rating

Very energy efficient - lower running costs

+9%

Not energy efficient - higher running costs
